NBSIR 73-105

Environmental Evaluation of Polyurethane Foam Core Sandwich Panel Construction

Final Report

Prepared for
Office of Research and Technology
Department of Housing and Urban Development
Washington, D. C. 20410

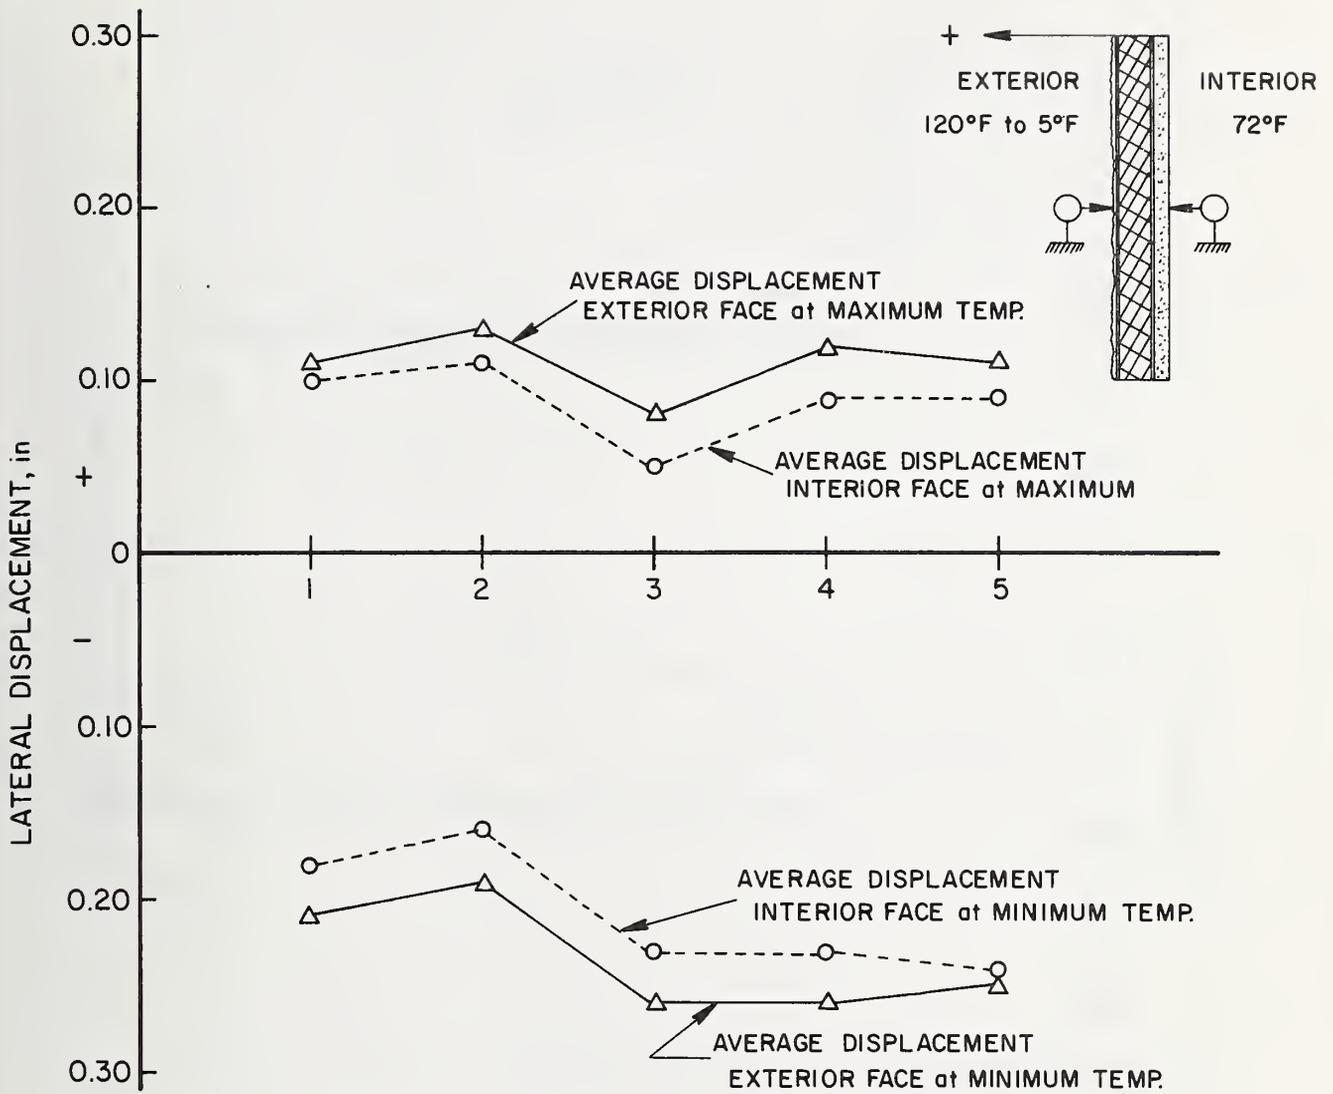
FIGURE 13. WALL DISPLACEMENT DURING TYPICAL 5 DAY PERIOD OF TEST

The lateral movement of both the interior and exterior sides of the test wall were recorded during the test and the average displacements for a typical 5 day segment of the test are shown in figure 13. The corresponding maximum and minimum average temperatures on the interior and exterior surfaces are shown for the same period in figure 14. The equivalent uniform load ranges for this period are shown in figure 15.

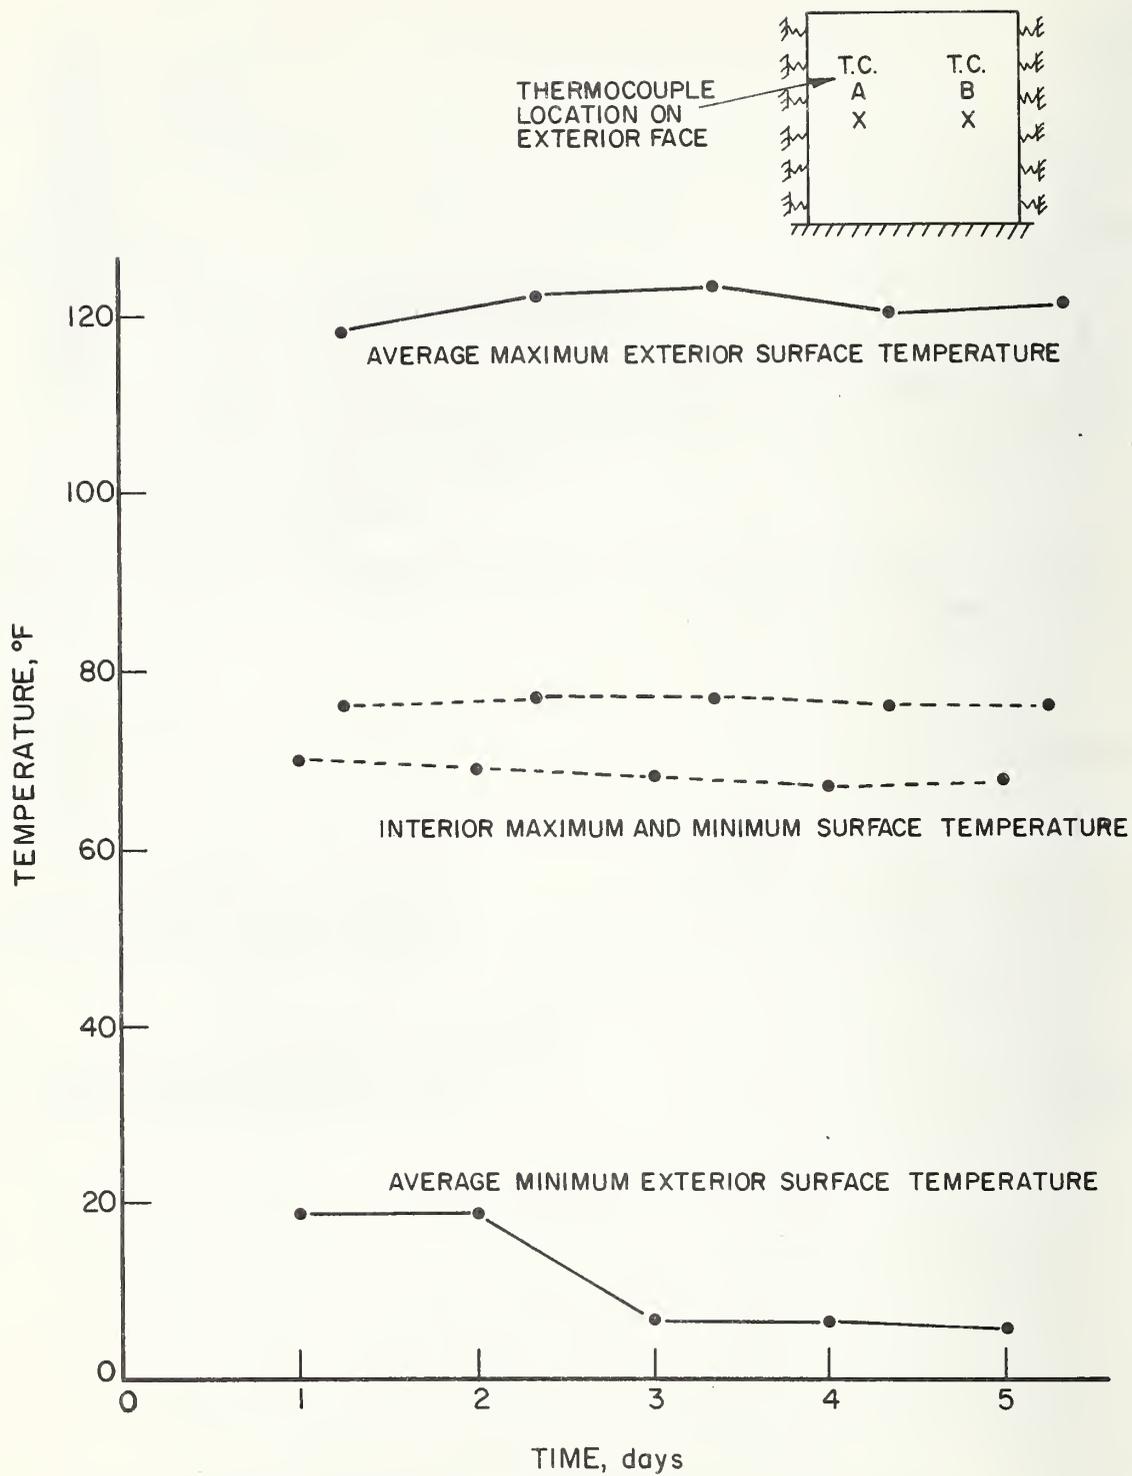
FIGURE 14. TEMPERATURE VARIATION DURING TYPICAL 5 DAY PERIOD OF TEST

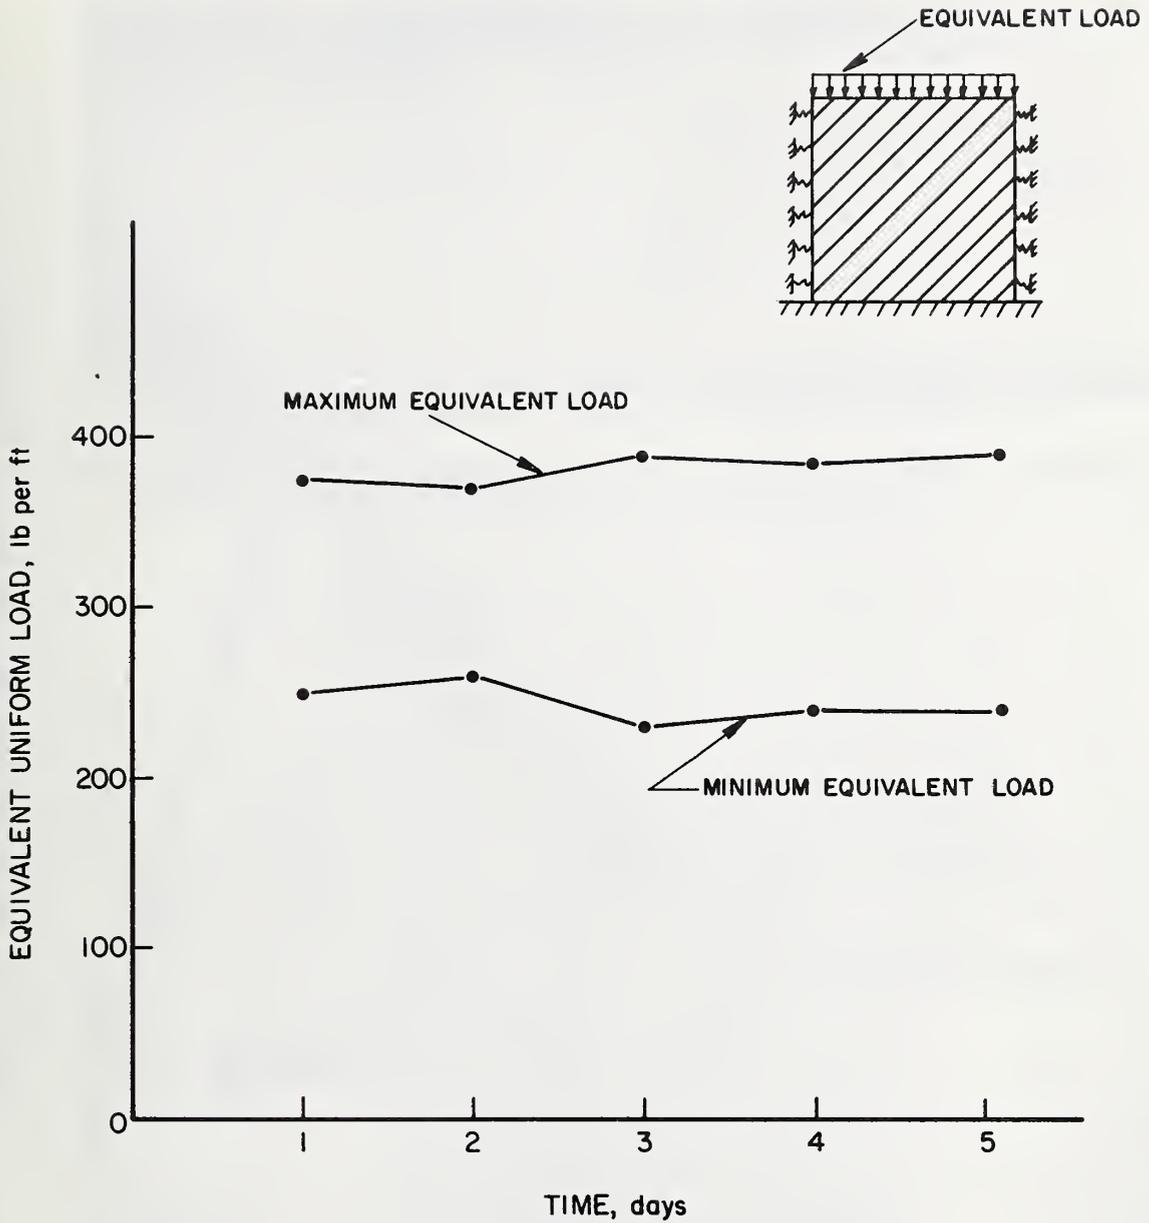
FIGURE 15. EQUIVALENT LOAD VARIATION DURING TYPICAL 5 DAY PERIOD OF TEST

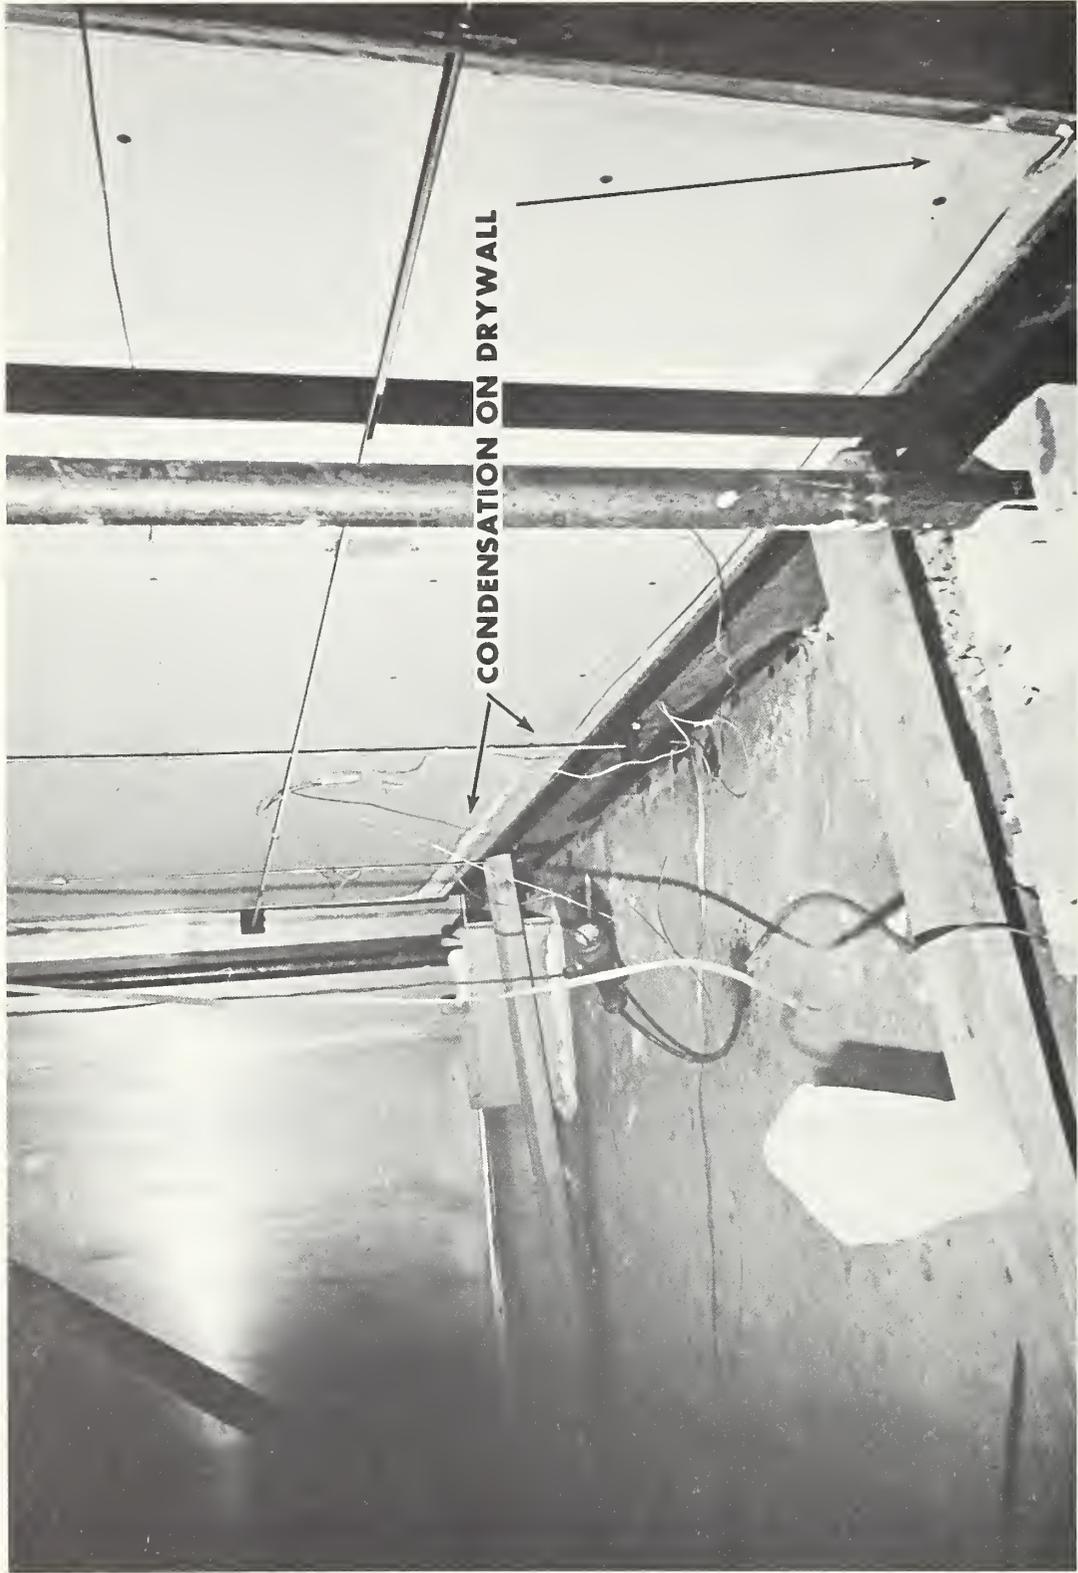
FIGURE 16. MOISTURE CONDENSATION ON INTERIOR FACE

The only visible indication of any undesirable effect during the test period was moisture condensation on the surface of the gypsum drywall along the base through-wall extrusion during the low temperature portion of the thermal cycle as can be seen in figure 16.

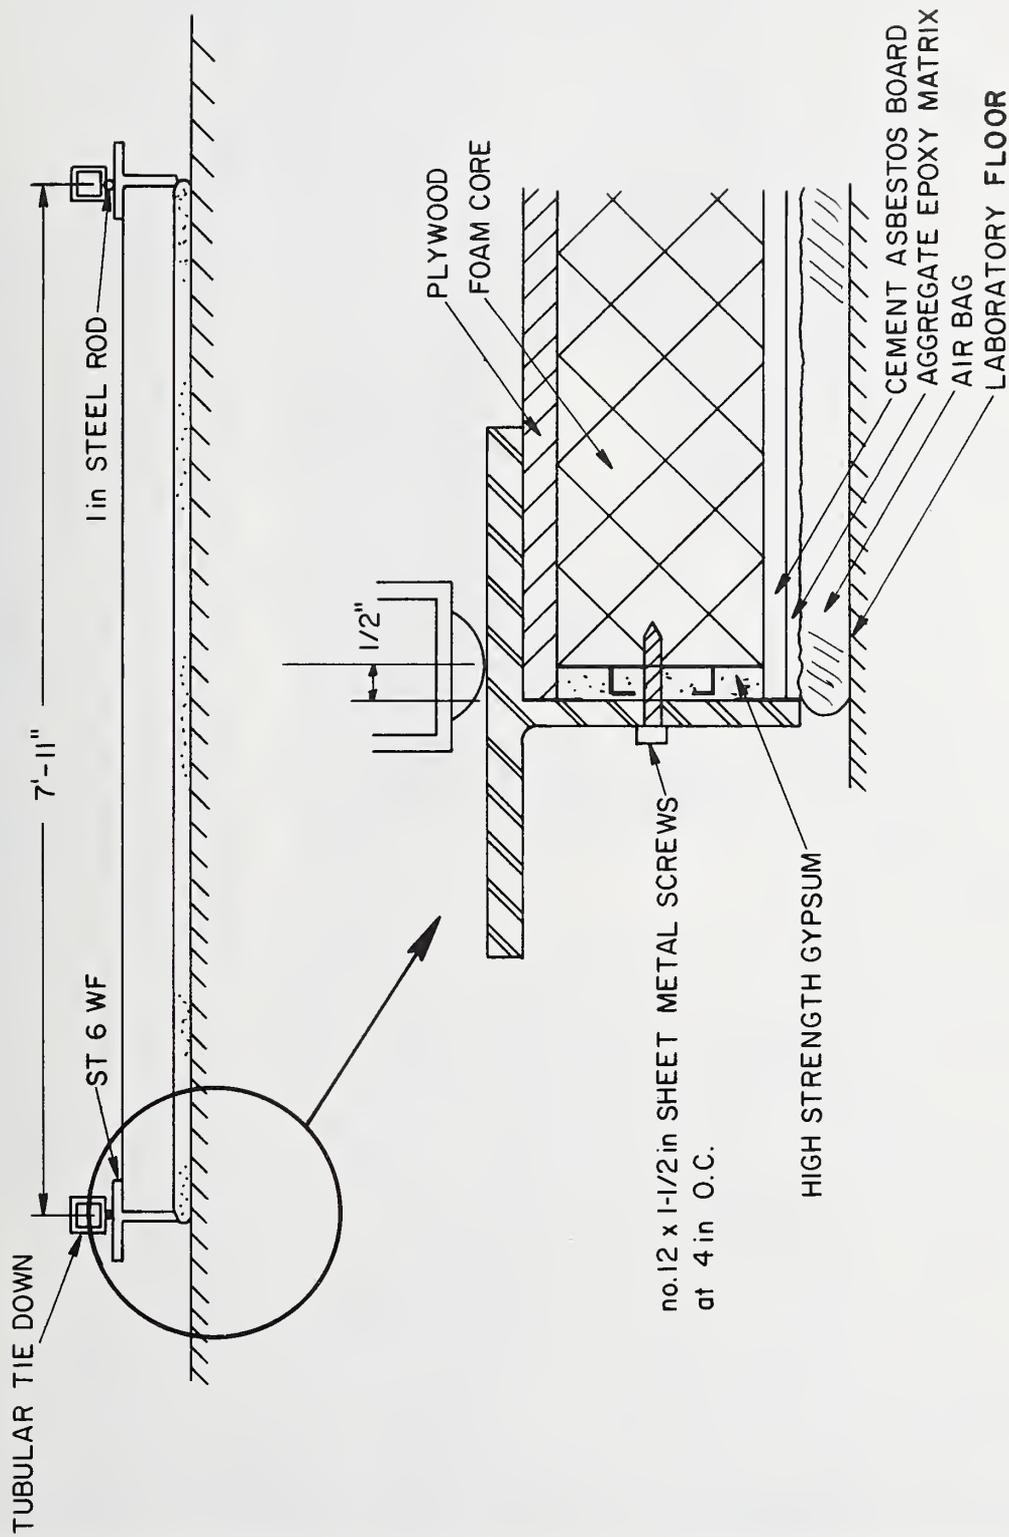
FIGURE 17. SCHEMATIC FOR SHORT-TERM FLEXURAL TEST

The wall panel was tested with an air bag located between it and the laboratory floor as shown in figures 17 and 18. The overall panel length was 96 in and the support-to-support dimensions was 95 in. The specimen supports were square tubular tie down beams with a roller at one end and a knife edge at the other.

Three linear variable differential transformers (LVDT) were placed at midspan to record vertical movement with one over each side extrusion and one at the centerline of the

specimen. X-Y recorders plotted air bag pressure versus mid-span deflection.

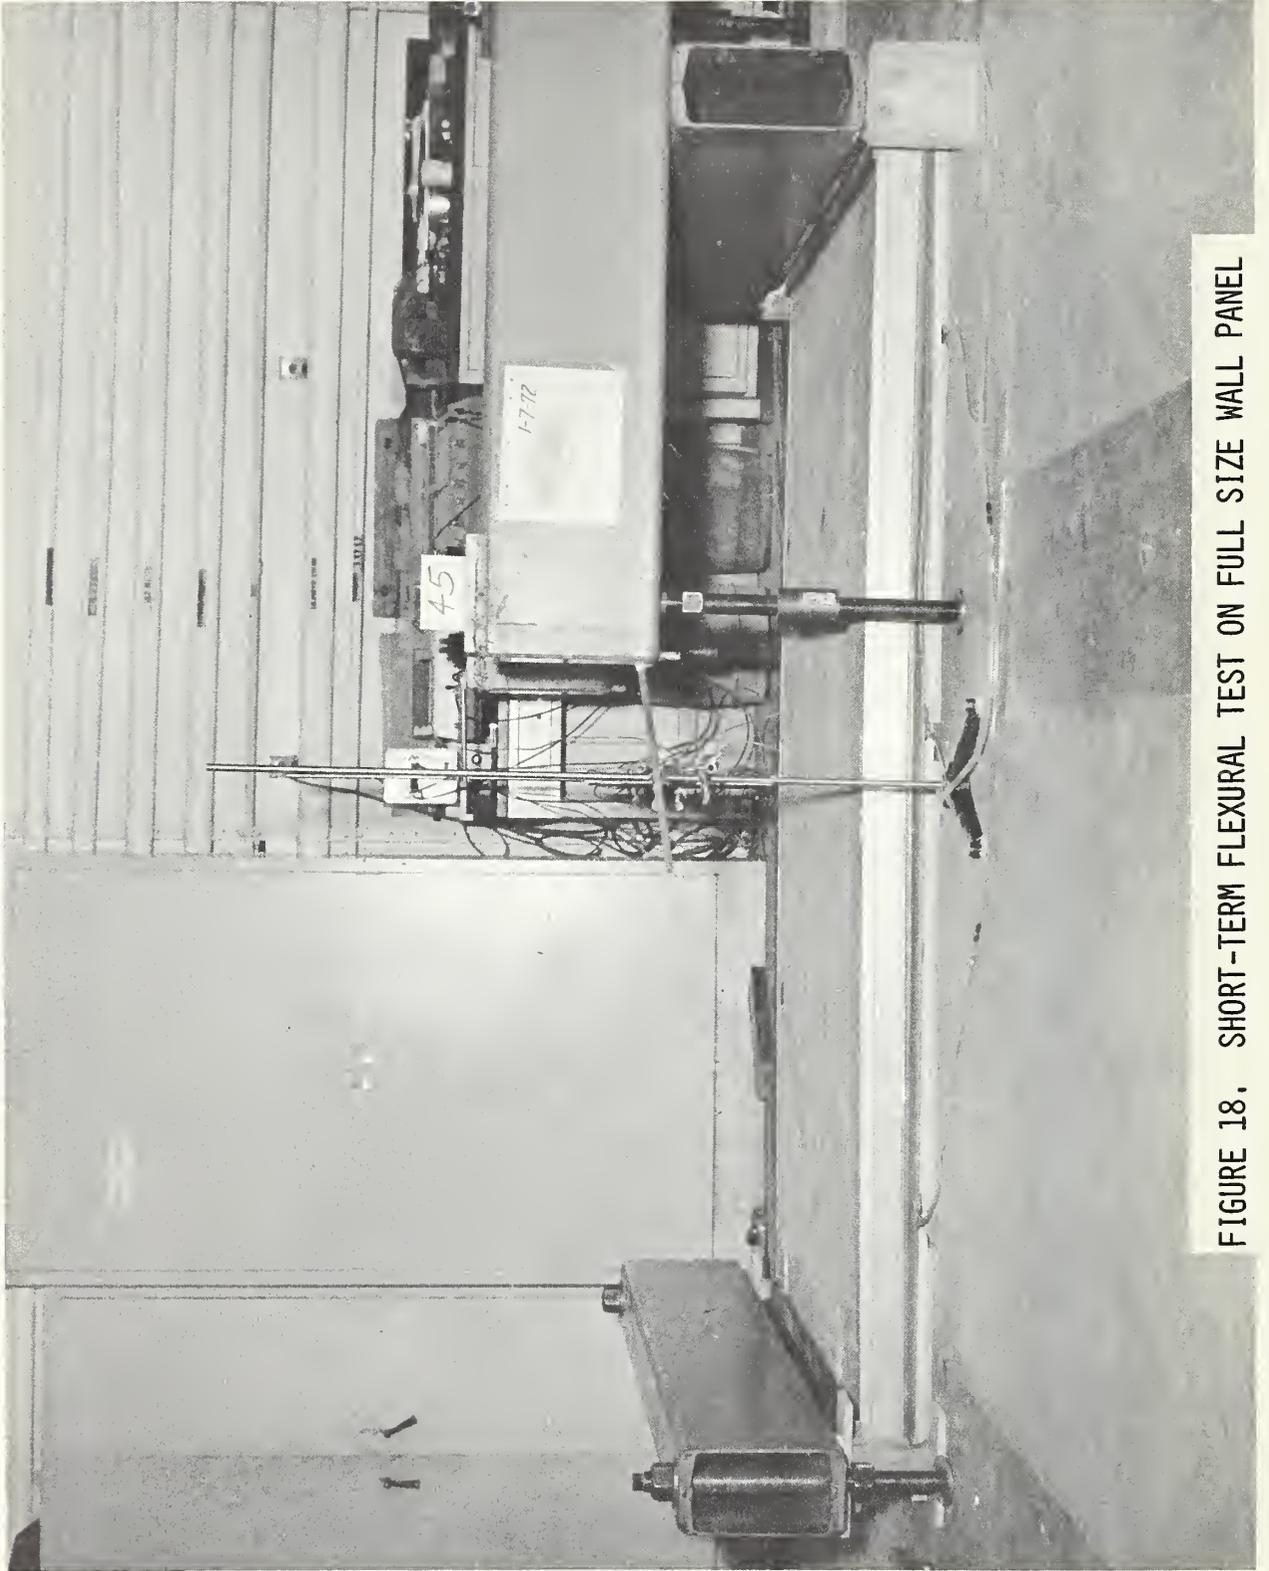
FIGURE 18. SHORT-TERM FLEXURAL TEST ON FULL SIZE WALL PANEL

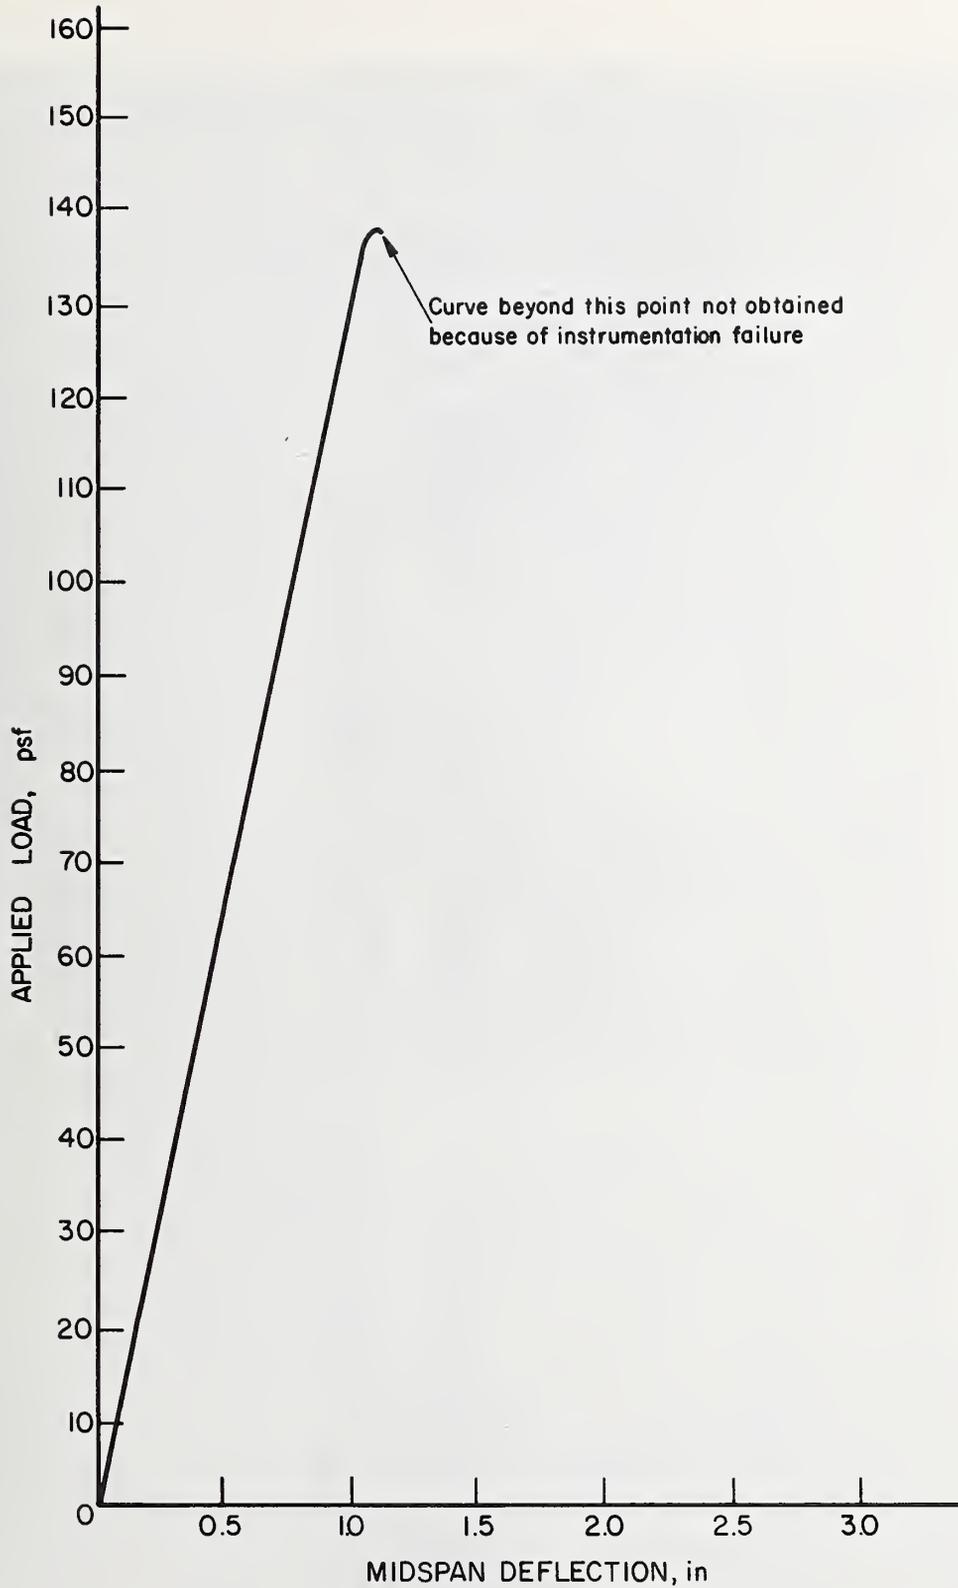
FIGURE 19. SHORT-TERM FLEXURAL TEST RESULTS ON SPECIMEN
CONDITIONED BY PROCEDURE 1

The wall panel conditioned by Procedure 1 was subjected to a uniformly applied load until failure which occurred at approximately 136 psf. Figure 19 shows the average load-deflection history of the midspan LVDT's. Failure occurred as the aluminum side extrusions separated from the panel at the quarter point leading to longitudinal cracking of the cement asbestos board on the compression face of the panel (see figures 20 and 21). Ten cycles of the load between 0 and 25 psf did not lead to a progressive increase in deflection.

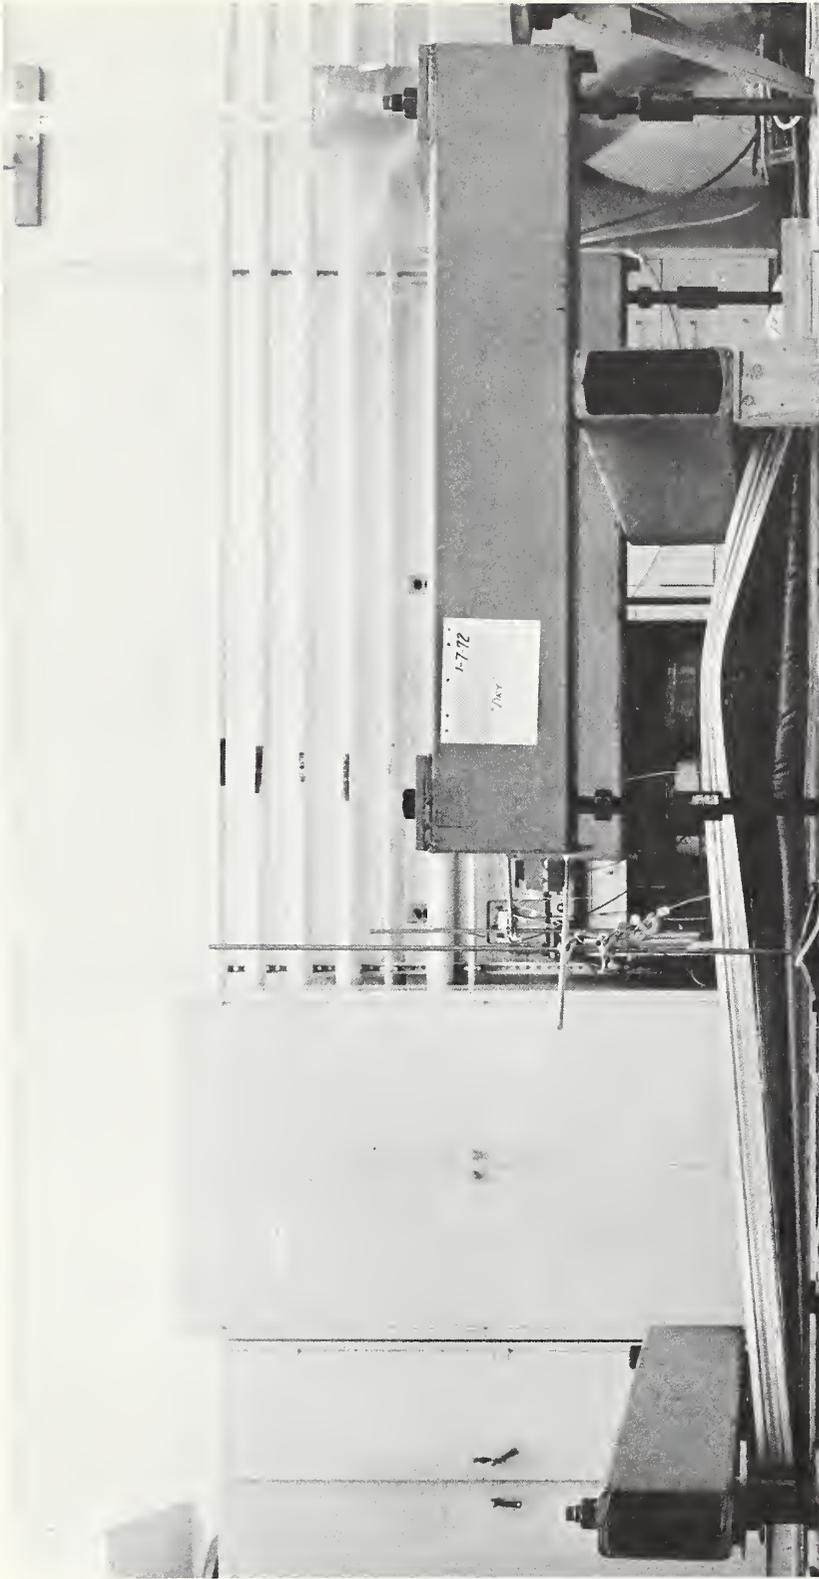
FIGURE 20. SHORT-TERM FLEXURAL TEST SPECIMEN CONDITIONED BY PROCEDURE 1 SHOWING FAILURE AT QUARTER-POINT

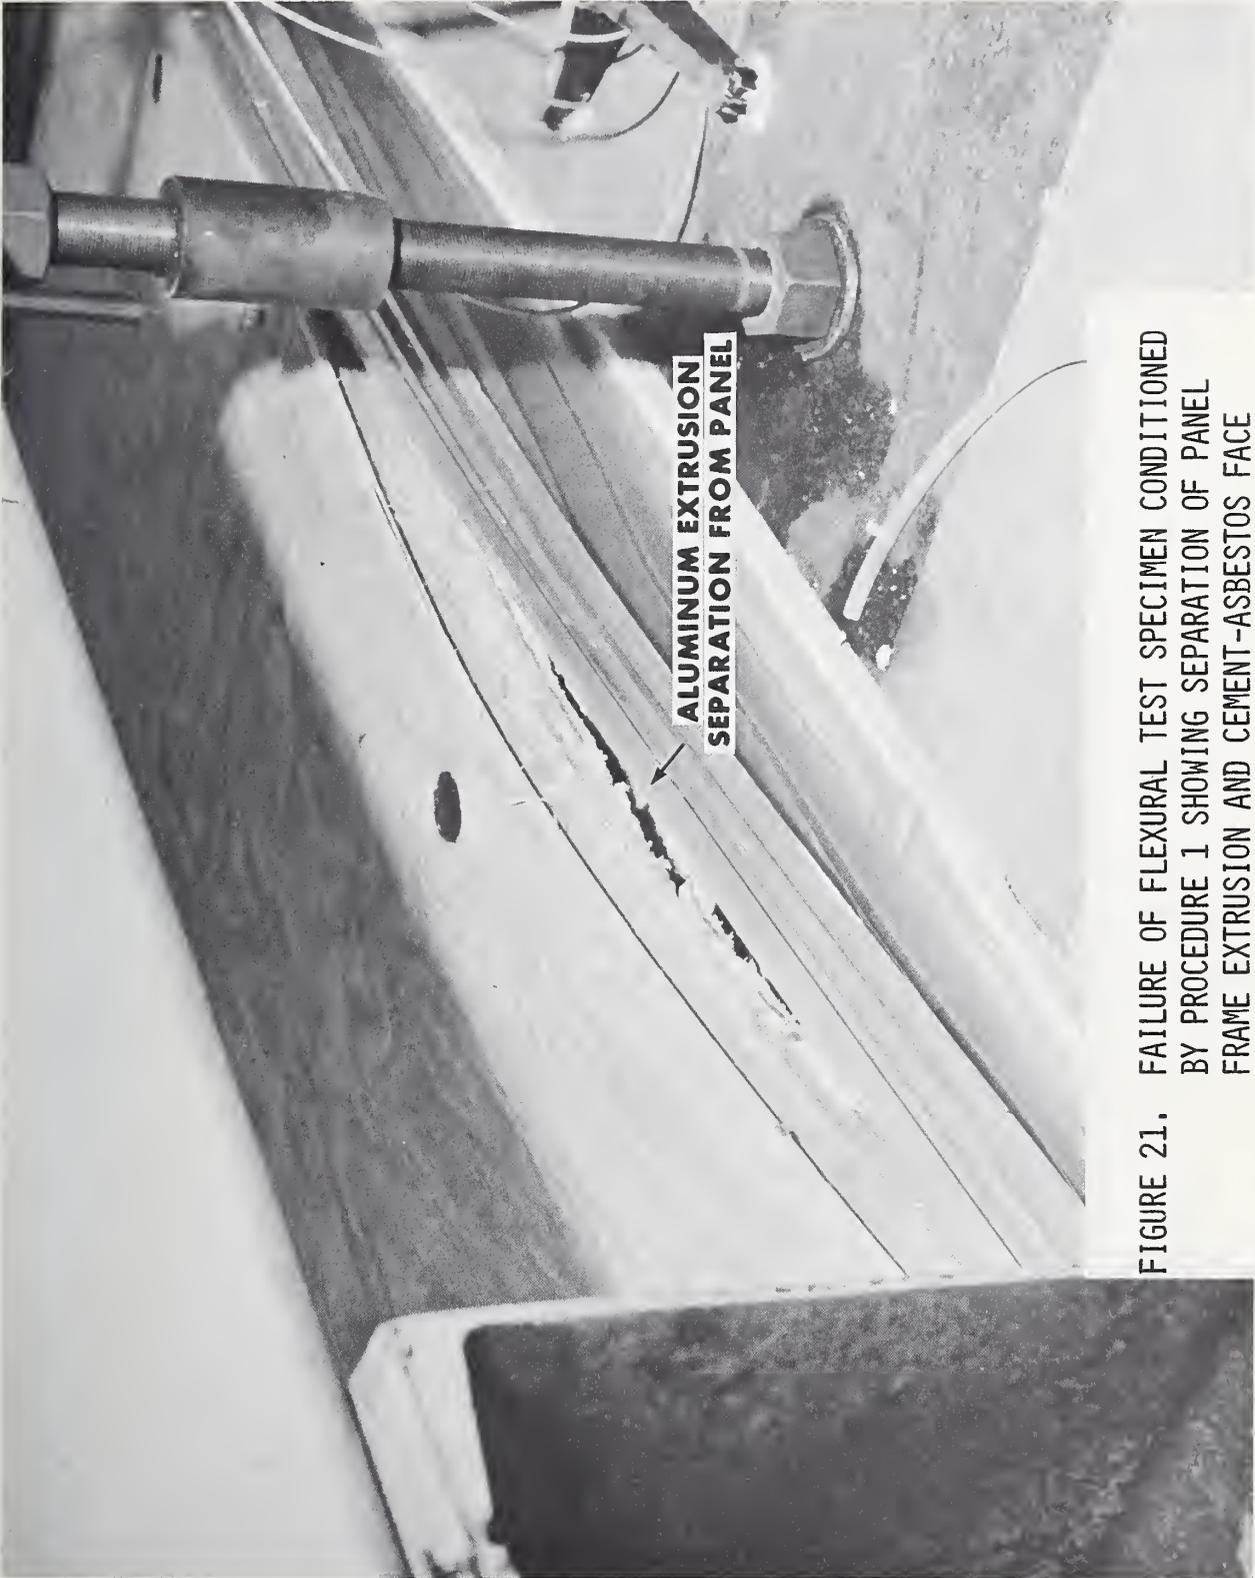
FIGURE 21. FAILURE OF FLEXURAL TEST SPECIMEN CONDITIONED BY PROCEDURE 1 SHOWING SEPARATION OF PANEL FRAME EXTRUSION AND CEMENT-ASBESTOS FACE

3. Failure in compression and flexure occurred as the aluminum side extrusions separated from the panel indicating the attachment of the frame to the panel faces is a significant factor in maintaining structural integrity.
4. The performance of the wall segment under load during the simulated in-service environmental conditions was satisfactory.
5. For this type of sandwich panel construction, the aging process cannot be properly evaluated by the currently accepted accelerated aging procedures for small specimens.

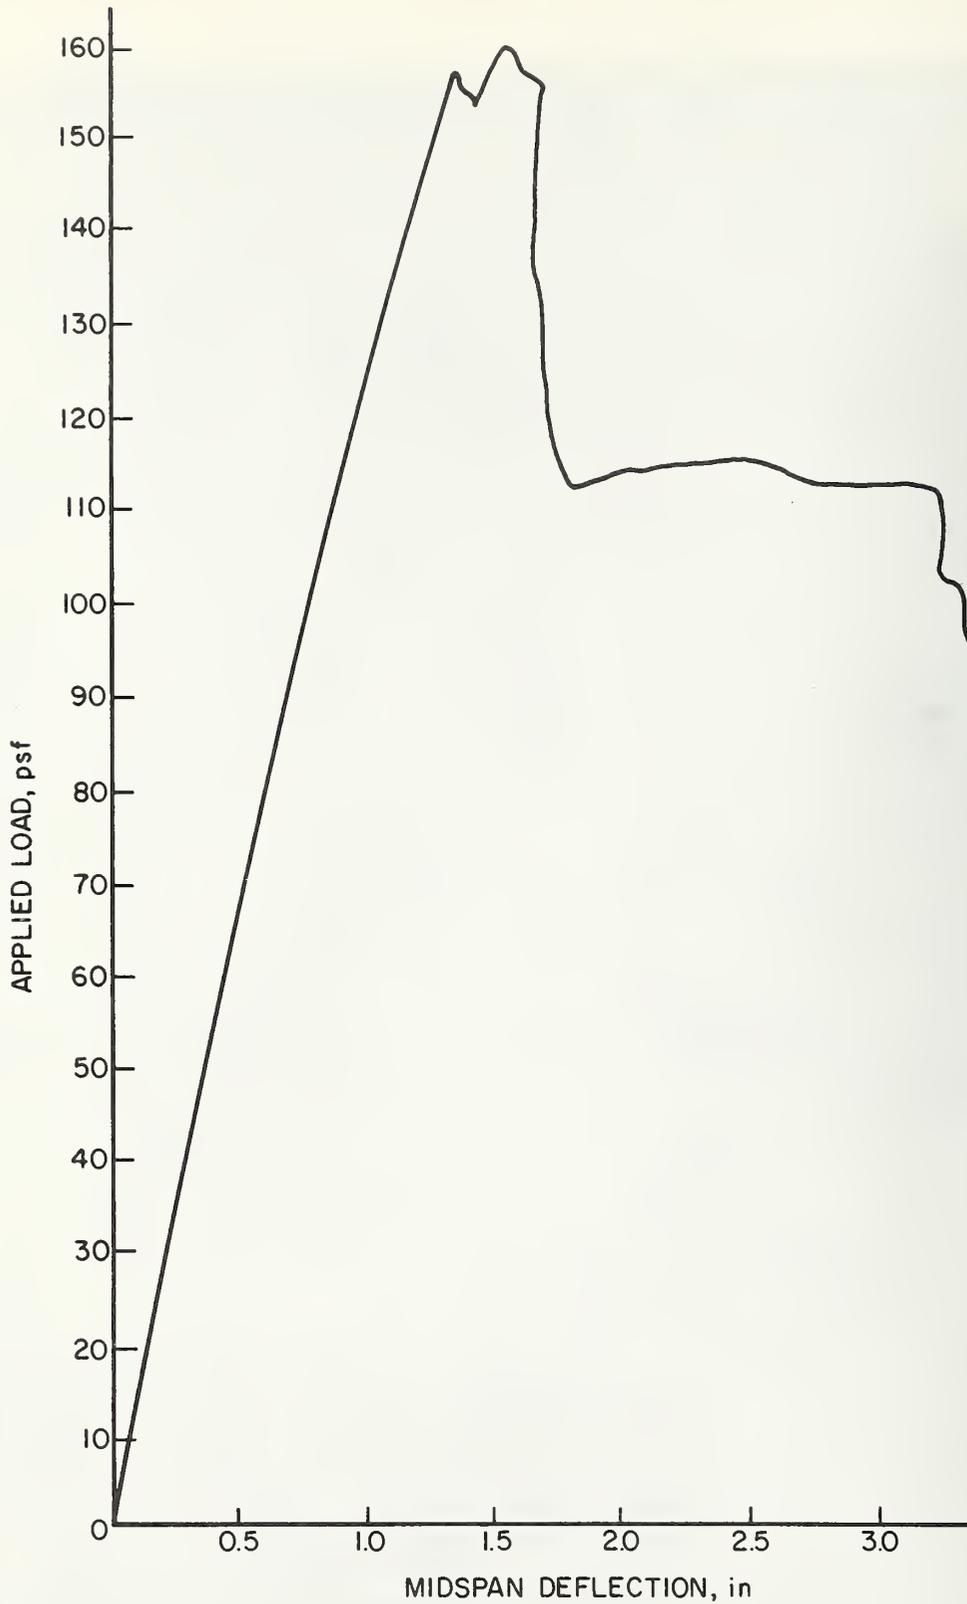
FIGURE 22. SHORT-TERM FLEXURAL TEST RESULTS ON SPECIMEN
CONDITIONED BY PROCEDURE 2

The wall panel conditioned by Procedure 2 was subjected to a uniformly applied load until failure which occurred at approximately 168 psf. Figure 22 shows the average load deflection history of the midspan LVDT's. Failure occurred as the aluminum side extrusion separated from the panel at one end (see figures 23 and 24). Again, ten cycles of the load between 0 and 25 psf did not lead to a progressive increase in deflection.

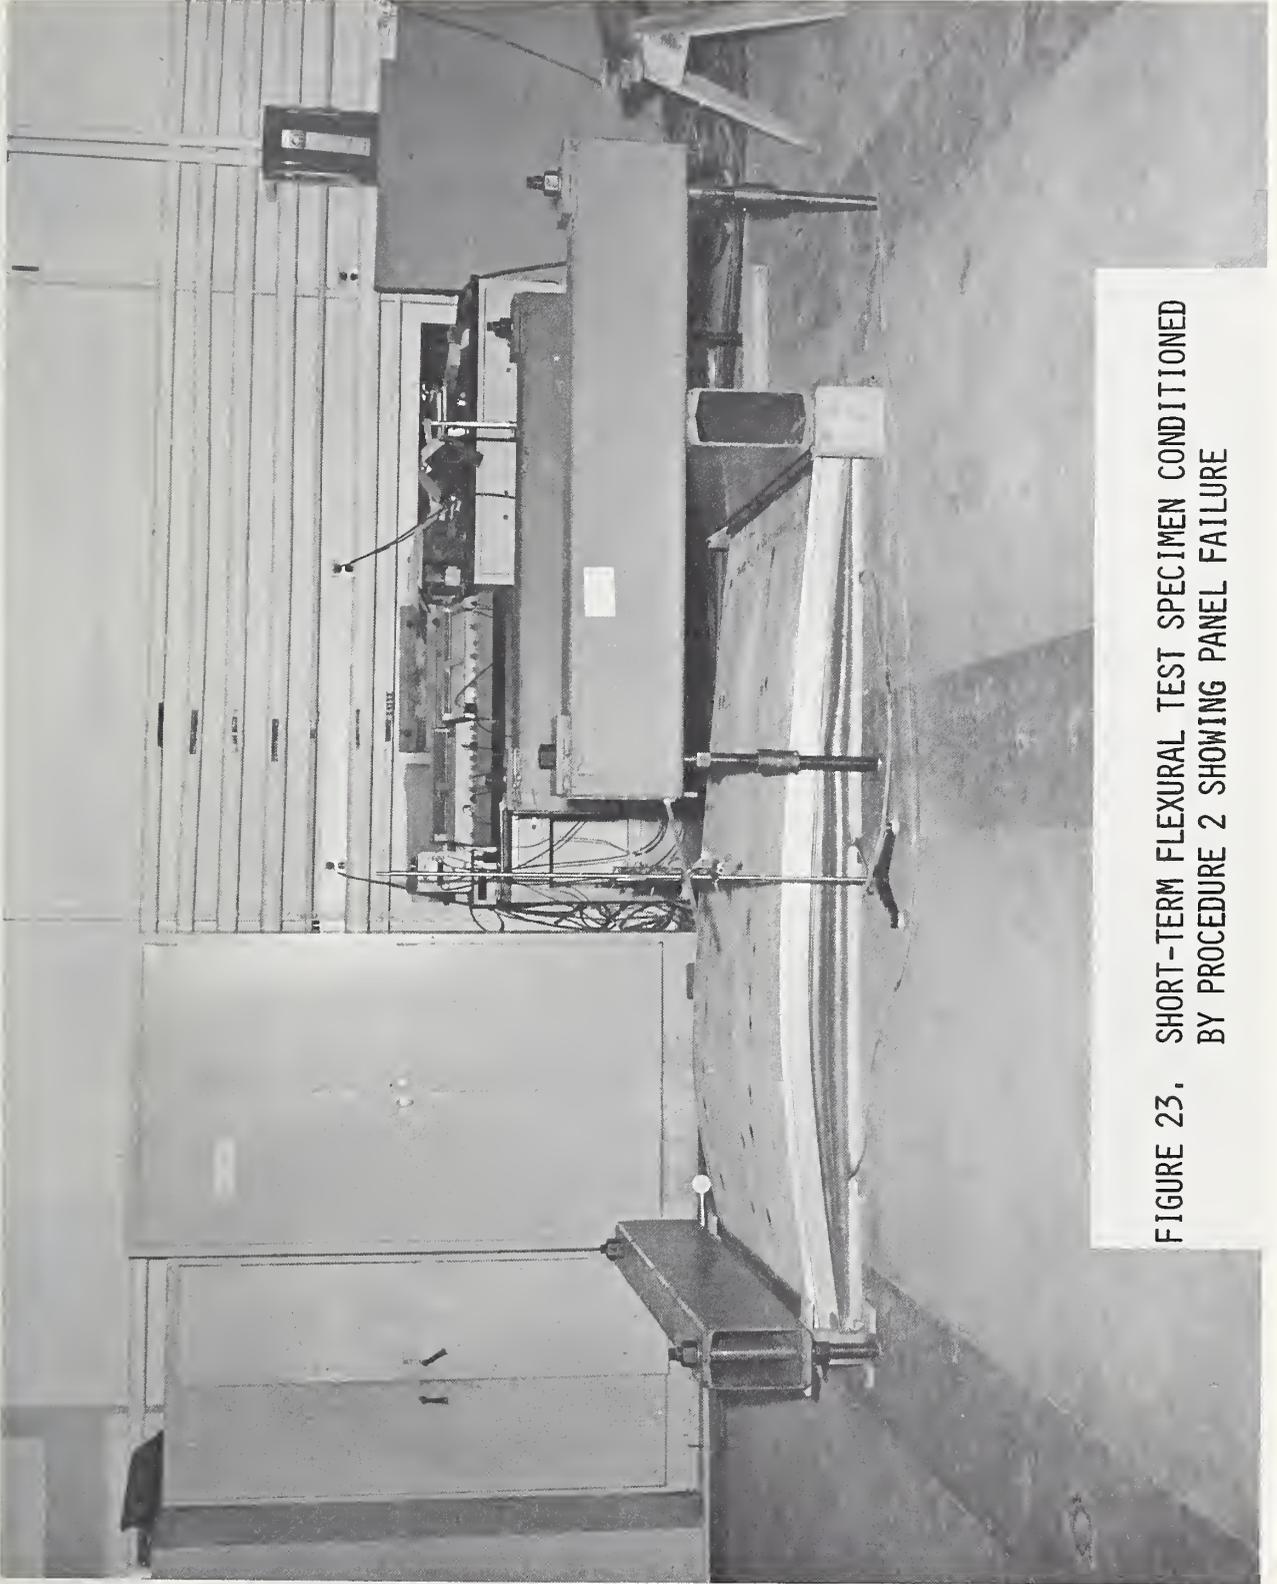
FIGURE 23. SHORT-TERM FLEXURAL TEST SPECIMEN CONDITIONED BY PROCEDURE 2 SHOWING PANEL FAILURE

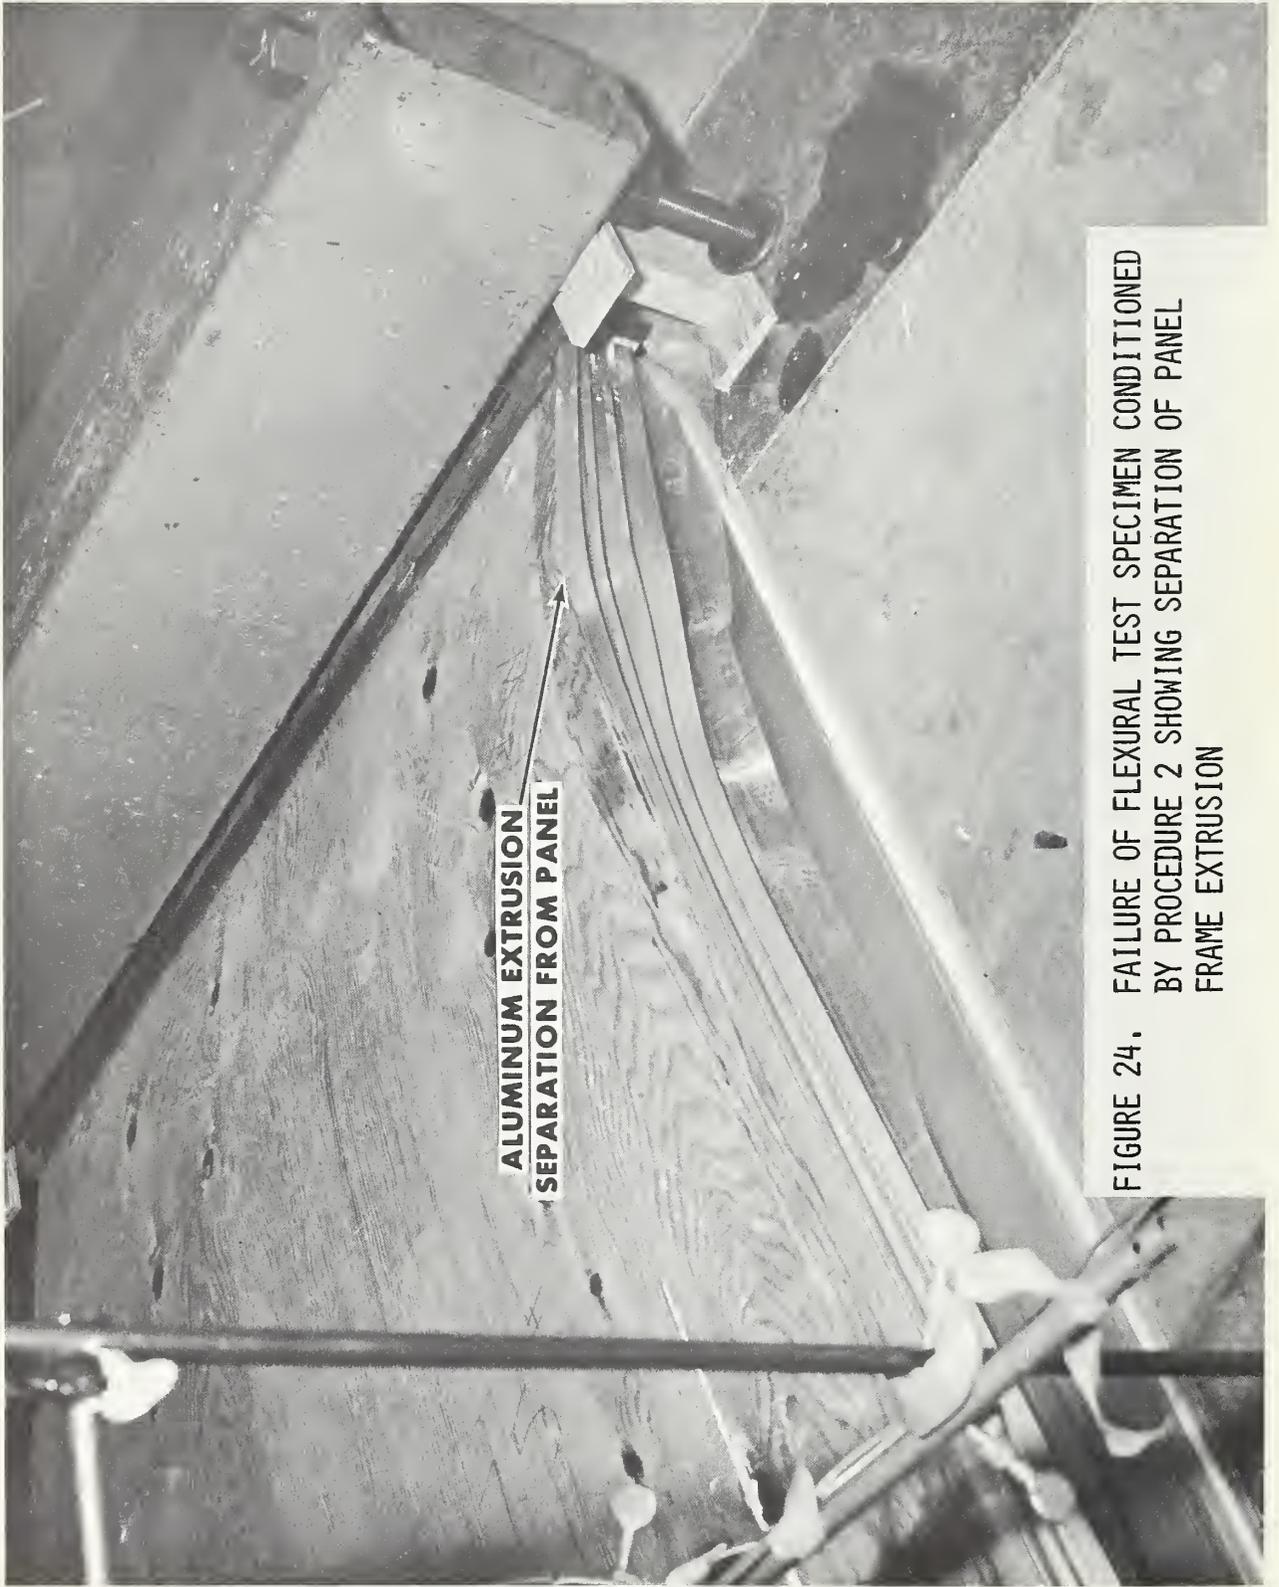
ALUMINUM EXTRUSION
SEPARATION FROM PANEL

FIGURE 24. FAILURE OF FLEXURAL TEST SPECIMEN CONDITIONED BY PROCEDURE 2 SHOWING SEPARATION OF PANEL FRAME EXTRUSION
